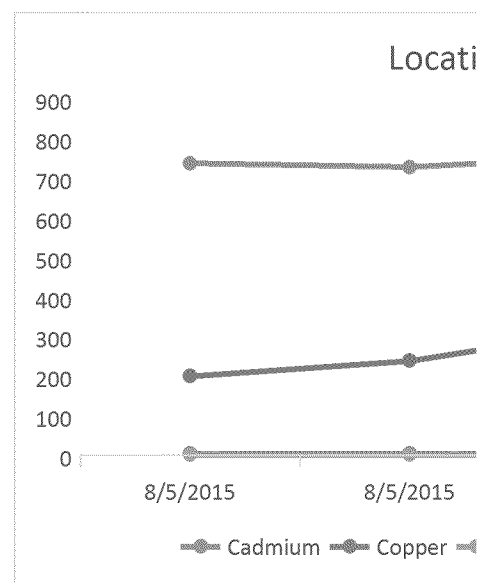
on: A68

Location ID	Date Sampled	Cadmium	Copper	Lead	Manganese	Zinc
A68	8/5/2015	0.828	3.45	0.232	737	199
A68	8/5/2015	0.815	3.16	0.283	727	238
A68	8/5/2015	0.974	3.52	0.82	757	324
A68	8/6/2015	0.85	3.26	0.329	817	326

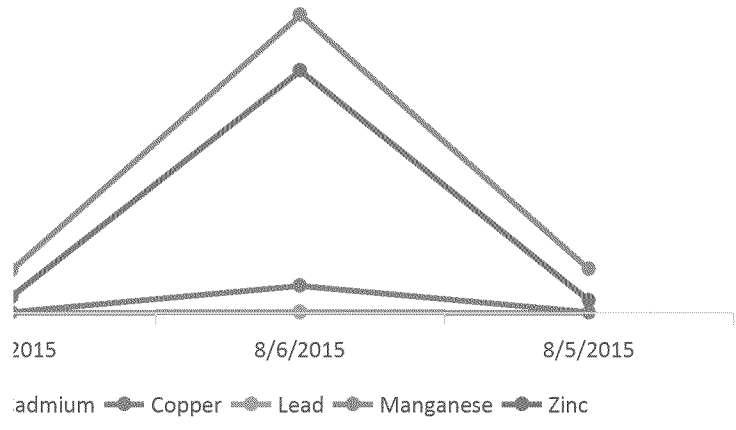
Location: Bakers Bridge

ocation ID	e Sampled	Cadmium	Copper	Lead	Manganes	Zinc
Bakers Bri	8/6/2015	0.336	1.88		296	110
Bakers Bri	8/6/2015	5.32	189	1.56	2090	1700
Bakers Bri	8/5/2015	0.353	2.28		306	85.8

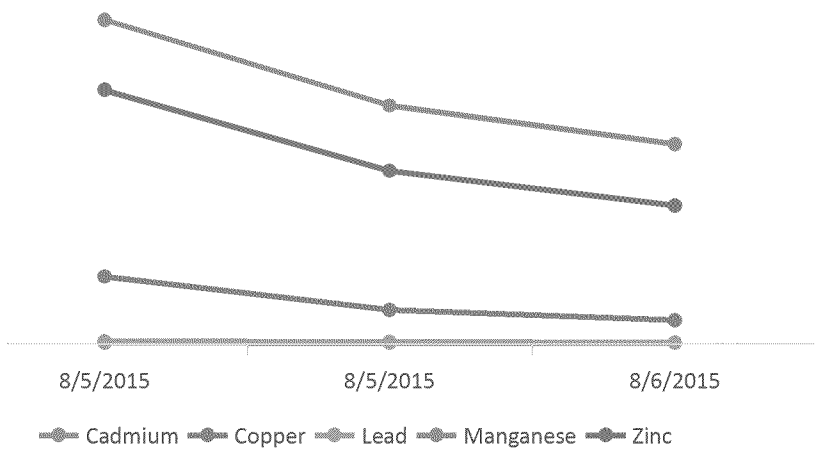
Location: CC48

ocation ID	Sampled	Cadmium	Copper	Lead	Manganese	Zinc
CC48	8/5/2015	30.6	2260	73.9	10900	8540
CC48	8/5/2015	19.1	1130	54.1	8020	5820
CC48	8/6/2015	14.2	786	30	6720	4650
